United States Holocaust Memorial Museum
Accessibility Assessment
Summary Report

United States Holocaust Memorial Museum
Accessibility Assessment Summary Report
Assessment Date: March 1-2, 2011

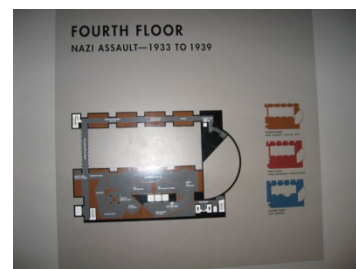
Visitor orientation can be provided through signage, maps, models, and publications designed to welcome and orient the visitor to the Museum. There is a Museum model available for visitors who take the Guided Highlights tour, but it is not generally available to visitors without prior reservation. In the Holocaust Permanent Exhibition each floor has an exhibit floor map. These maps are a missed opportunity for a tactile overview of the exhibit space for persons who are blind.

Recommendation: Provide a tactile map of the exhibit layouts on each floor to provide an orientation for persons who are blind.

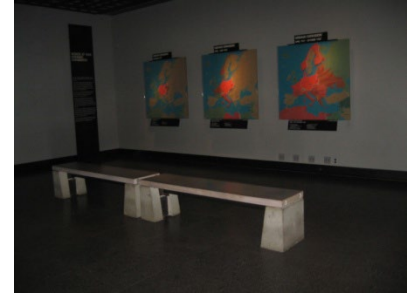
The German Expansion maps are placed under Plexiglas and are a missed opportunity for a tactile experience for visitors who are blind.

Recommendation: Provide alternate maps that can be tactilely explored in conjunction with an audio described tour.

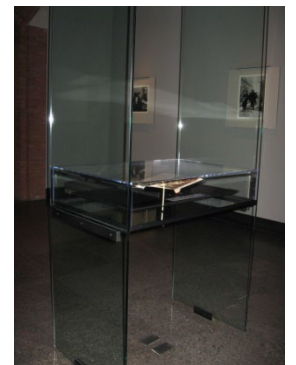
In this area of the Museum there are photos of Jewish pre-war life on walls, four benches in the room, and in center of room, a Plexiglas case holding the Haggadah. The displayed material lays flat and is unable to be read from a seated position. The display case is an obstruction in the circulation path for persons who are blind as it exceeds the maximum height of 27 inches above the finish floor (ABAAS 307.2).

Recommendation: Angle the displayed text so that it is positioned 32” to the bottom of the case, 40” to the top. Lower the display case so that it is cane detectable and so that the information inside the case can be read from a seated position.

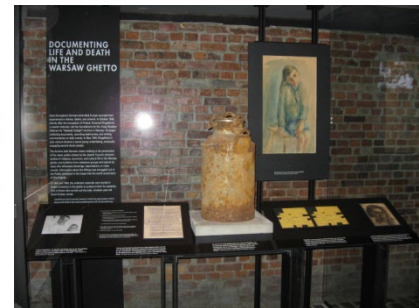
This exhibit has very small font sizes on the exhibit panel. The text on the rear panel is not visible unless the visitor is right in front of the glass because it is blocked by an angled exhibit panel in front. A visitor in a seated position would not be able to read the bottom of the text.

Recommendation: Raise the rear exhibit panel so the bottom text clears the height of the front angled panel.

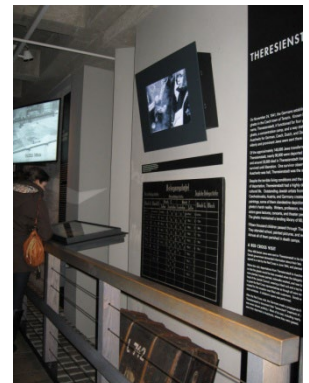
Three videos are shown in this area – two are considered graphic and are blocked by concrete walls at 41 inches high. A small label signifying the videos as graphic is on front of wall and is easily blocked by visitors. The video screens cannot be viewed by people of short stature or those seated in wheelchairs. The original solution for accessibility was to install a very small screen that is raised from behind the wall and locked in place with a pin. The unit is very heavy, high and not an equal experience. The most recent alternative

suggestion by the Museum is to provide a screen on the front of the wall and have visitors use a swipe card to activate it. The unit would turn off when the film is over. NCA does not recommend this solution for a number of reasons. First, a visitor would have to know in advance to request the swipe card before going up to the exhibit area, and this would be the only exhibit requiring such access. Secondly, placing a screen on the front of the wall makes the graphic video viewable by any passerby and thereby we question why any visitor would need to be screened from its viewing via the privacy wall. And lastly, the location of the exhibit is in an area that can get congested with people stopping to look over the privacy wall and the screen on the front of the wall most likely will get blocked by the crowds.

Recommendation: The Museum should determine if these videos are still considered too graphic for viewing. At the time of installation, these were deemed too graphic, but may not be so by today's standards. If not, then remove the privacy wall. If they are continued to be viewed as too graphic then consider moving the videos to a privacy station nearby so that the screen can be placed in a lower viewable position for viewing from a seated position. An alternative option is to place the videos in a cubicle arrangement similar to the American Responses exhibit on the fourth floor, somewhere in the general exhibit area if possible.

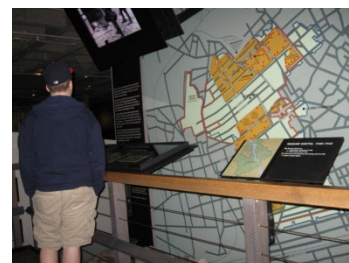
The exhibit panels sit 46 inches back from railing with 18 point font making it difficult for a visitor with low vision to read. The map of the ghettos is not provided in tactile format.

Recommendations: Provide a smaller tactile map of the ghettos.

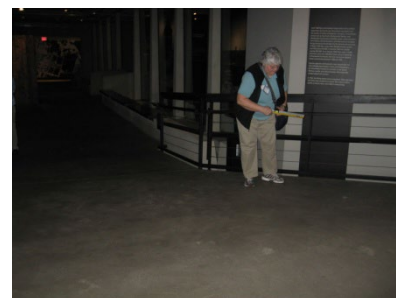
Ramp (concrete) leading down from railcar area to the concentration camp area exceeds running slope requirements at 9.5 percent at the top. The ramp widens at the top (12' 4") so the handrail angles along the path of travel. The handrail is 33 inches above the floor.

Recommendation: Raise handrails to minimum 34 inches and maximum 38 inches. **Recommendation for the slope—did we have one?**

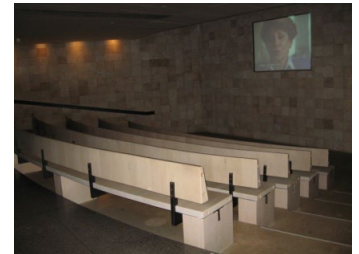
The film is shown in a small amphitheater with 5 benches with back support and no armrests. There are no wheelchair spaces except at the top and no companion seating provided. The side aisles are steps with metal handrails with square gripping surfaces and obstacles.

Recommendation: Provide companion seating on the back row of the amphitheater (moveable chairs) and designate this area as reserved for wheelchair seating. Replace handrails with gripping surfaces per ABAAS 505.7 and continuous along their length-ABAAS 505.6.

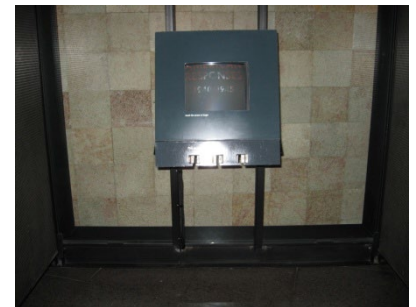
This area consists of eight small individual cubicles with small video screens that play 5 different audio programs. The instructions on the screen are to "Touch Screen to Begin", and then programs are selected by touching the desired selection on the screen. There is no tactile or audio navigation for the screens and therefore are not operable by persons who are blind.

Recommendation: Provide audio navigation and/or redundant tactile buttons on screen frame. An alternative navigation is with audio feedback and touching the screen twice or lingering on it to activate a selection (like the iPad, iPhone). Assistive listening recommendation applies here.

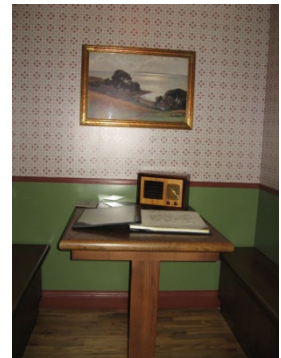
The small table in the “dining table” area that holds Daniel’s diary does not have knee and toe clearance for a forward approach for a wheelchair.

Recommendation: Reposition the table to allow for a forward approach.

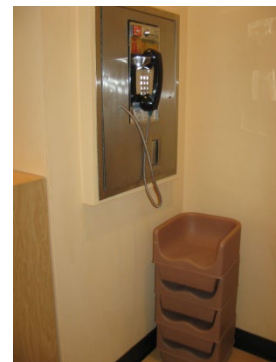
Some self-service shelves and dispensing devices are out of reach range that is 48 inches maximum. The child booster seats block the clear floor space at the public pay telephone.

Recommendation: Move the booster seats out of the clear floor space of the public pay phone. The café will be undergoing some renovation and as that occurs, reach ranges for self-service and dispensing devices should be adjusted.
