The Bogliaco Bartolani Chapel in the Holy Gates Cemetery, Florence. Survey and Analysis for Restoration.

OLIMPIA BARBIERI GENTILI CALCAGNINI, GABRIELLA GORETTI, ANGELA MANCUSO AND MILENA ROCCABRUNA University of Florence, Italy

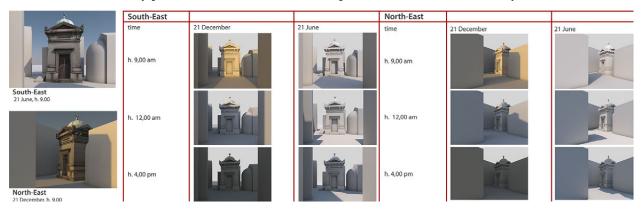
Figure 8. Study of the incidence of solar rays on the fronts of the chapel.

We began the study by cataloguing the different materials of which the chapel is composed. Then an examination of the laying of blocks helped us to understand how the Serena sandstone blocks were used by Fantappiè. This was followed by a study of the chapel's orientation and the way the sun struck it in different seasons and times of day. Finally, we identified the various form of deterioration of the building materials and mapped them, comparing the damage with the incidence of the solar rays; this was done with the Physical Render on Maxon Cinema 4D. Sunshine affects the chapel's state of decay in a variety of ways. The chapel lies on the southwestern rampart of the Cemetery of the Holy Gates. It is surrounded on three sides by chapels, while its southeastern facade, the front, is open and unshaded for several meters so it enjoys plentiful sunshine all year round. The other sides are so close to other chapels of the same height that little sunshine reaches them.

This orientation study provides an overview of what prevents solar radiation all year round.

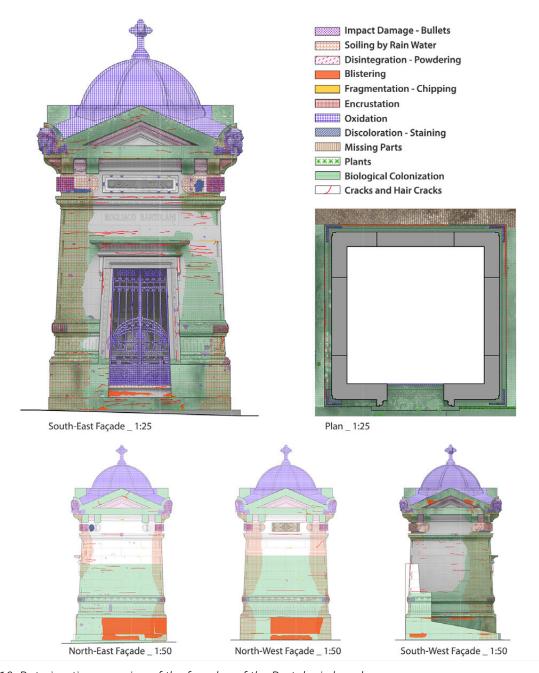
Figure 10. Deterioration mapping of the facades of the Bartolani chapel.

The long-standing lack of maintenance of the chapel is clearly demonstrated by traces of decay. In particular, the surfaces of the Serena sandstone blocks have been discolored due to dripping rain water that carried traces of bronze, limestone, and the copper of the roof.

The runoff of the rain water was originally guaranteed by the tightness of copper roofing and the rods connected to it. The rods, discrete and functional even in the absence of drainpipes, prevented the rainwater from soiling the surface of the sandstone. Now the main cause of the alterations to the surface and the color of the Serena stone is the roofing; severely oxidized and deformed, and missing in several places, it allows the release of oxides, and the moisture cannot pass out of the masonry. Large drops flow from the cornices closest to the cover, and in particular from the zones underlying the bronze bas-relief decorations depicting the Medusa heads. From there it spreads along the corners of the building, down to the ground. A thin but extensive biological patina almost completely covers the walls, altering the original appearance of uniformity. In areas less exposed to sunlight and in the basement, the bright green color of the wall denotes the presence of moss. Conspicuous are also the oxidation of the elegant wrought iron gate, now largely damaged. The deposits in various shades of light green present on angular slabs finely decorated with bas-relief bronze contrast chromatically with the brown base. These deposits are due both to the deposit of dust as well as other pollutants in the atmosphere and to the chemical attack by leaching meteoric material. Also noted is manmade degradation, mainly present on both the stone wall and on the entrance gate, where there are a number of holes, perhaps due to a criminal act such as the discharge of firearms [Vergès-Belmin 2008].

Description: Any alteration or loss of material in a built heritage, clearly due to a mechanical action or manually induced.

lack of maintenance and neglect; vandalism; wars and/or fires.

Description: Deposit of a very thin layer of exogenous particles giving a dirty appearance to the stone surface. The contaminants are transported to the surface by dry deposition or wet deposition, such

as rainwater intrusion. Water pathways are often limited to narrow stripes on the stone cornice, along a well-shaped edge.

presence of biodeteriogens; atmospheric pollutants (soot and dust); hydration (some minerals change their color when in contact with water, changing the colors of the structure); staining from water absorption: damp areas; minerals that exhibit a color change when exposed to light, heat, radiation; chemical assault caused by run-off rainwater (acid rain) and deposit of atmospheric particles; differentiated support absorption.

Description: Loss of cohesion or granular disintegration of finely grained stones.

thermal stresses; water leakage and capillary rising damp; presence of biodeteriogens; crystallizations of soluble salts; freezing/thawing cycles.

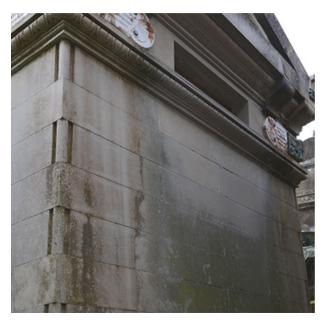
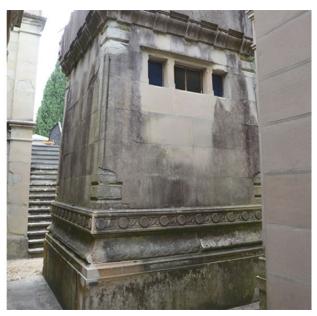
Figure 14. The back wall of the two chapels: Bartolani on the left and Toja on the right.

The two chapels are both characterized by a high rear window. Another similarity on the backside is the presence of dripping rainwater that carried with it part of the colors and materials of the cornices and the overlying decorations.

Even in this case, as to the staining by oxidation, the similarity of the deterioration is geometrically evident: the most protected area has maintained a light gray to beige; the most affected area has changed its color in a mixture of dark gray and moss green.
