The Ruspoli Chapel at the Holy Gates Cemetery in Florence. Material and diagnostic survey for conservation.

ANNA L. CIUFFREDA, ELENA J. ALONSO, PETRONILLA PATTI, SARA SOLDAINI
University of Florence, Italy

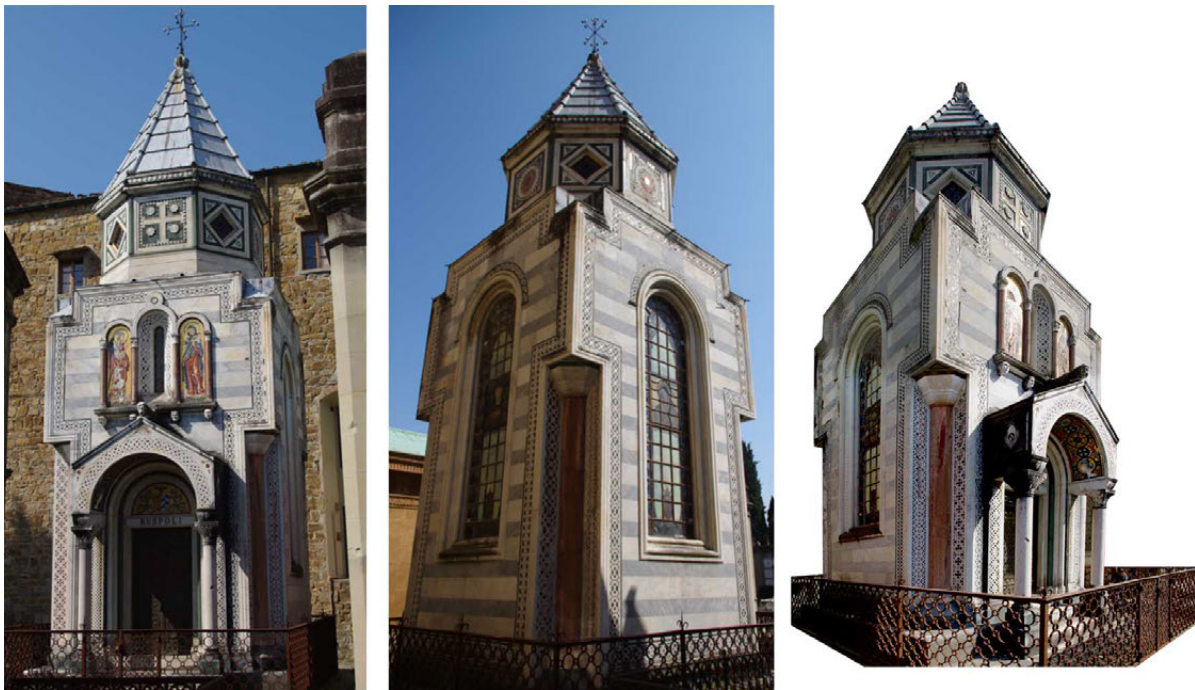
Figure 5. The Ruspoli Chapel. Holy Gates Cemetery (Firenze).

The Ruspoli Chapel (Fig. 5) was designed in 1891 for the Valsè-Pontinelli family in a Neo-Byzantine style, and built by Michelangelo Giovannozzi.

The plan is square, with a porch with round arches on granite columns. The main facade is defined by a circular portal with a round arch. The lunette bears the coat of arms of the owners. At the top, on the sides of a window, is represented the Annunciation. The building is topped by a dome covered by the lantern. The other facades are decorated with stained glass single windows made by Vincenzo Cambi.

The exterior surface, made of polychrome marble, was built by marble worker Michelangelo Giovannozzi, while the door and the outer grating were made by Luciano Zalaffi.

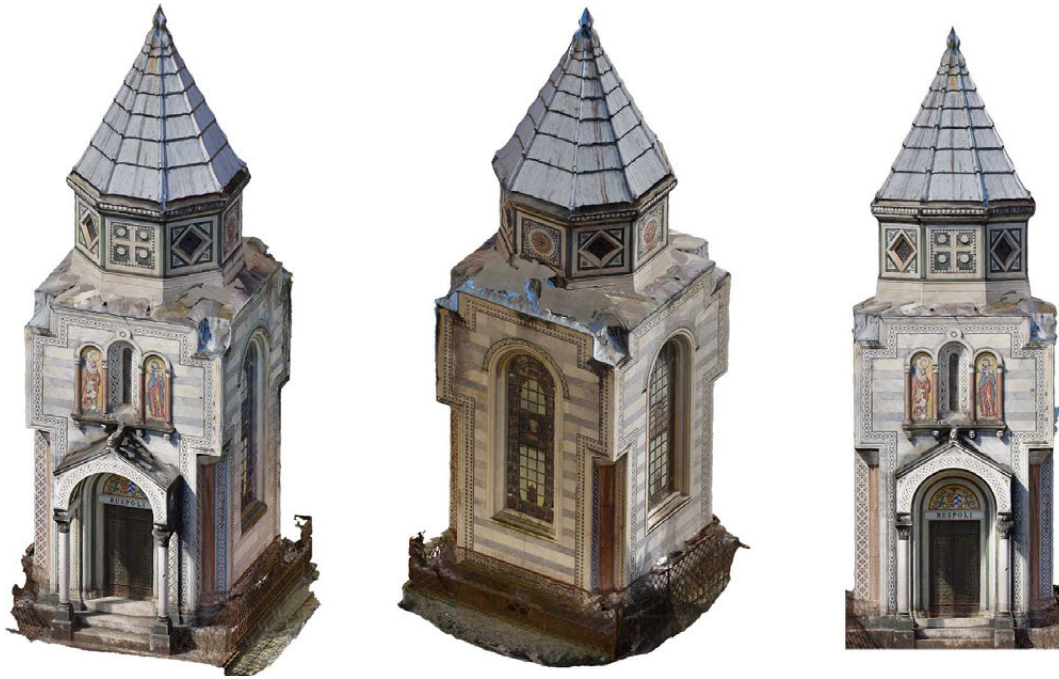
Figure 7. Photo modeling of the Ruspoli Chapel with Photoscan.

From photo plans, we delivered the entire geometry of the artefact back in cad, integrated with direct survey so as to obtain chromatic and material data (Fig. 7).

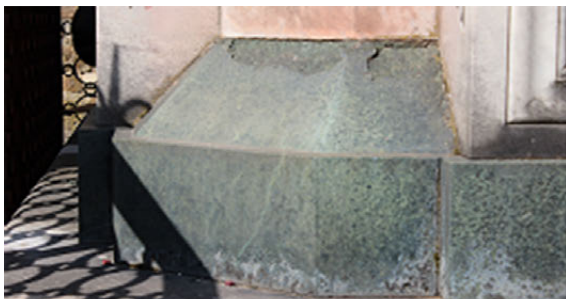
Figure 8. Verde Prato.

Verde Prato (Fig. 8) is a sedimentary rock that exists on Monte Ferrato in Figline of Prato (where some old quarries, now abandoned, can still be found) and in Impruneta.

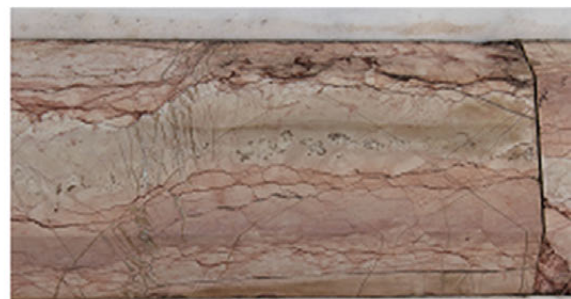
Figure 9. Ammonitic red.

The ammonitic Red (red Verona type) (Fig. 9) is a sedimentary rock that can be found near Monsummano Terme and Garfagnana; however, the marble of the chapel could have come from the quarries of Verona.

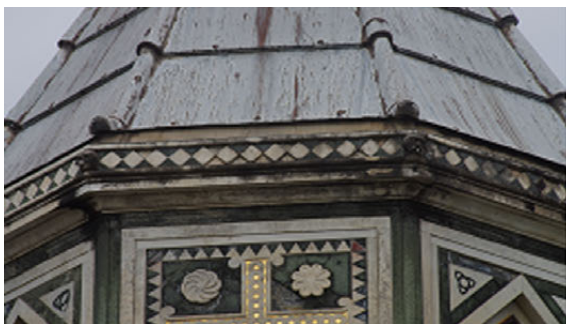
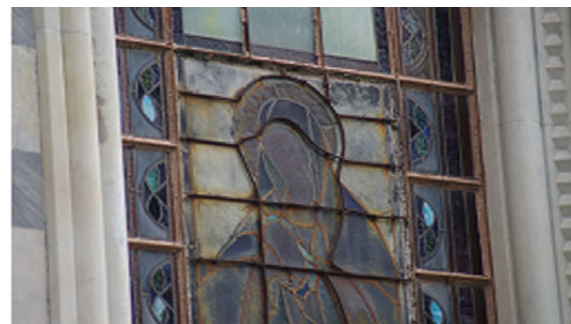
Figure 10. Lead on roof.

Figure 11. Glass and iron on decorated windows.

The chapel does not present a significant crack pattern. The framework of the facade's degradation presents some pathologies due to lack of maintenance (Figs 10 and 11). The most common form of degradation is a black crust, thicker on the capitals, gray, and thinner on the base segments (Figs 12 and 13). The biological patina impacts fronts and elements that are mostly exposed to the north, and

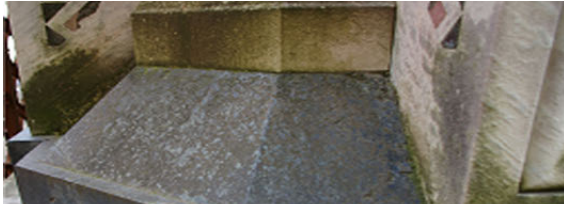
Figure 12. Black crust on the capitals.

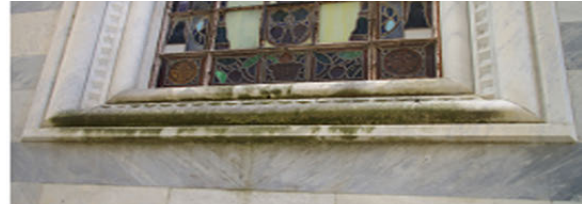
Figure 13. Biological patina on the east face.

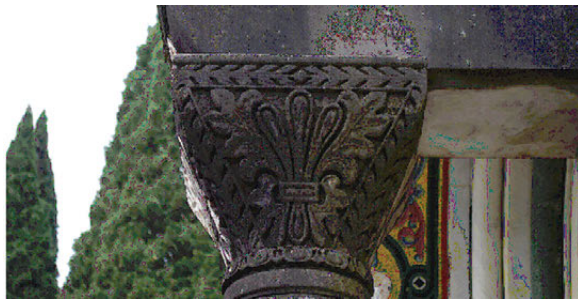
basements, where stagnant humidity is high. The disintegration in Verde Prato shows irregularly shaped deficiencies due to its grainy structure (Fig. 14). The White marble erosion is accentuated in the parts that are most exposed to the impact of water and wind (Fig. 15). The Red Ammonitic is characterized by a diffuse erosion in the corner columns, where the elements have been oriented with the veins orthogonal to the background surface, which has enhanced this effect.

Figure 14. Disintegration in Verde Prato.

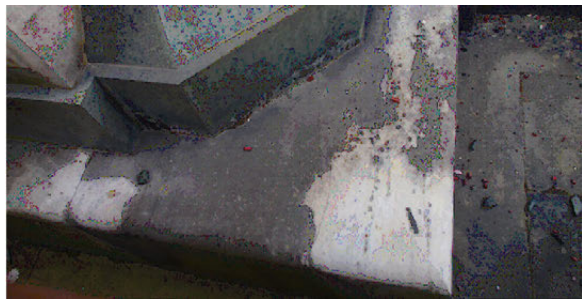
Figure 15. The white marble erosion.

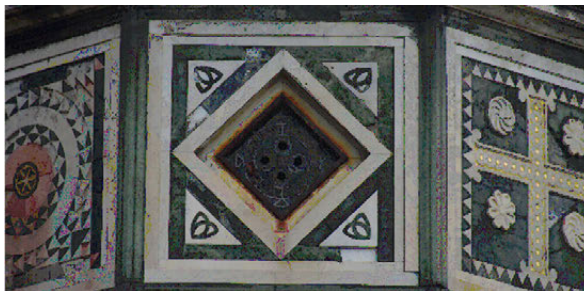
Figure 16. Red stain caused by the metal's oxidation.

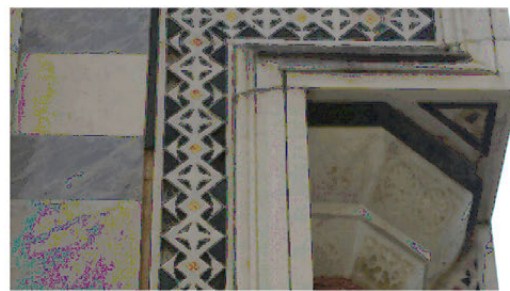
Figure 17. Lack of material.

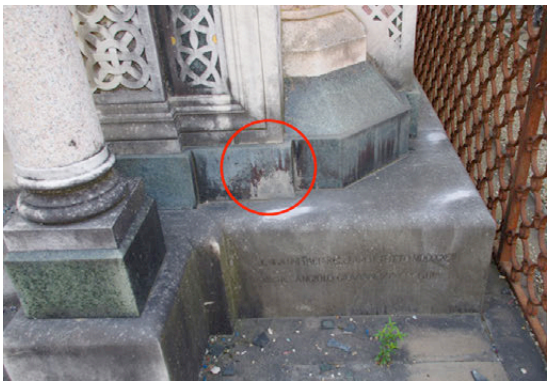
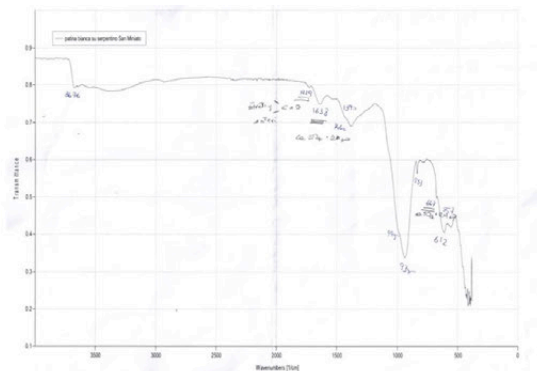
In the Ruspoli Chapel, we proceeded to the sampling of the white patina on serpentine to determine the type of material (Fig. 18). The sample was analyzed by means of infrared techniques (Fig. 19).

The graphic shows that the material was treated with gypsum and calcite, so we can presume that the chromatic alteration was caused by the stone's reaction after the treatment.

Figure 18. White film of Verde Prato sampled and analyzed. Figure 19. Infrared analysis of the white film.
