ENGINEERING GEOLOGY OF DAM SITE AND
SPILLWAY AREAS FOR THE MONROE RESERVOIR,
SOUTHERN INDIANA

by
JOHN D. WINSLOW
GARY R. GATES
WILTON N. MELHORN

Indiana Department of Conservation
GEOLOGICAL SURVEY
Report of Progress No. 19

1960

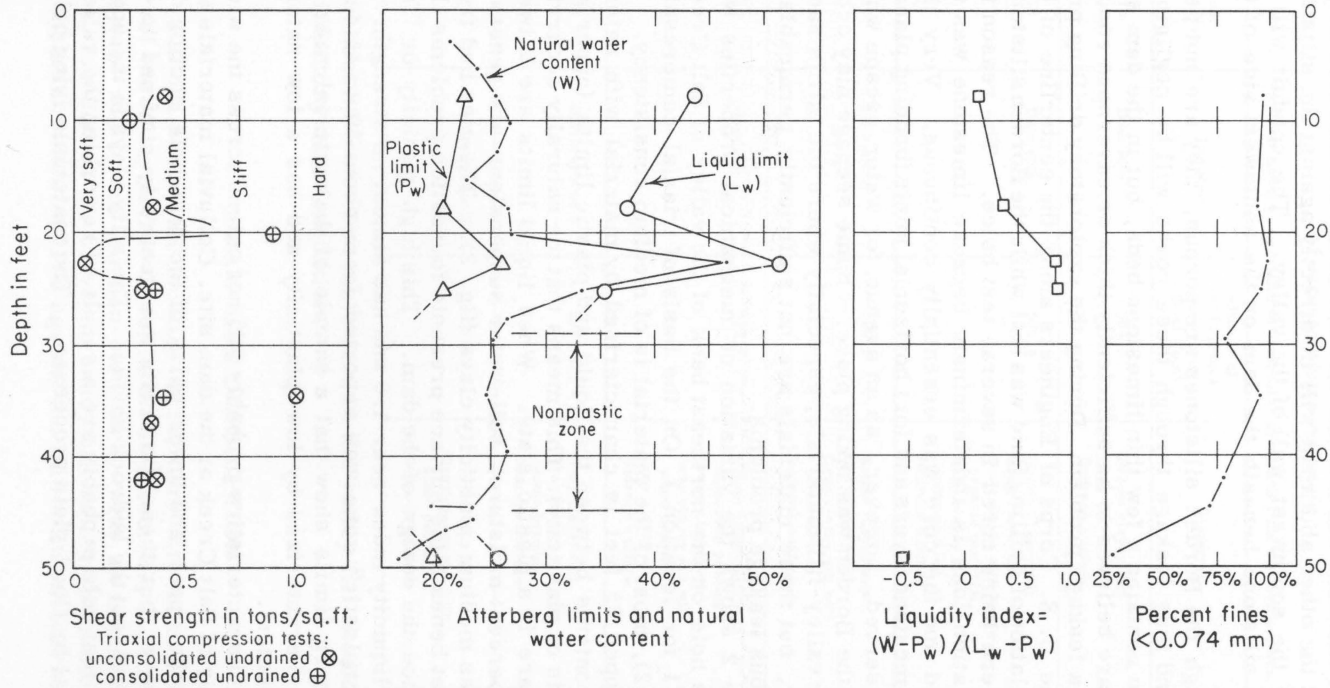
Figure 2.--Variation of engineering properties with depth for undisturbed samples (Denison sampler) from U. S. Corps of Engineers hole UC-201 on dam center-line. Data courtesy of U. S. Corps of Engineers.

⊙ Corp of Engineers hole UC-201
See figure 2

Figure 2 shows the variation of mechanical properties with depth for a hole on the northeast bank of the valley of Salt Creek. (See plate 1 for location.) On the basis of triaxial compression tests (fig. 2), most of the material is of medium consistency.

The upper 25 feet is characterized by material with natural moisture contents between the liquid and plastic limits (upper and lower limits of plasticity). This means that the naturally occurring materials are in a plastic state. When liquid limits are between 30 and 50 percent moisture, soil-water suspensions are generally classified as medium plasticity clays (fig. 2). The clay bed from 20 to 24 feet beneath the surface presents foundation problems that will influence the design of the dam. This high plasticity or "fat" clay has a liquidity index near 1.0 and has almost no strength. A middle "nonplastic" zone was reported from about 30 to 45 feet. The Atterberg limits show that a sample of the material near the bottom is characterized by low plasticity and has a low natural moisture content.

These characteristics probably will not extend across the width of the valley of Salt Creek at the dam site. Colluvial materials are present in the upper and lower parts of the test-hole section described above, but these materials are generally confined to the valley fill nearest the bedrock surface. The silty clays in the upper part of the test hole probably are a result of reworking the valley-fill material by flood-plain processes. The materials lying below

25 to 30 feet probably have not been reworked and may have been precompacted by thicker valley fill that has subsequently been removed.
