## Water Over Water: Hoosier Canal Culverts, 1832-1847

*Dennis K. McDaniel\**

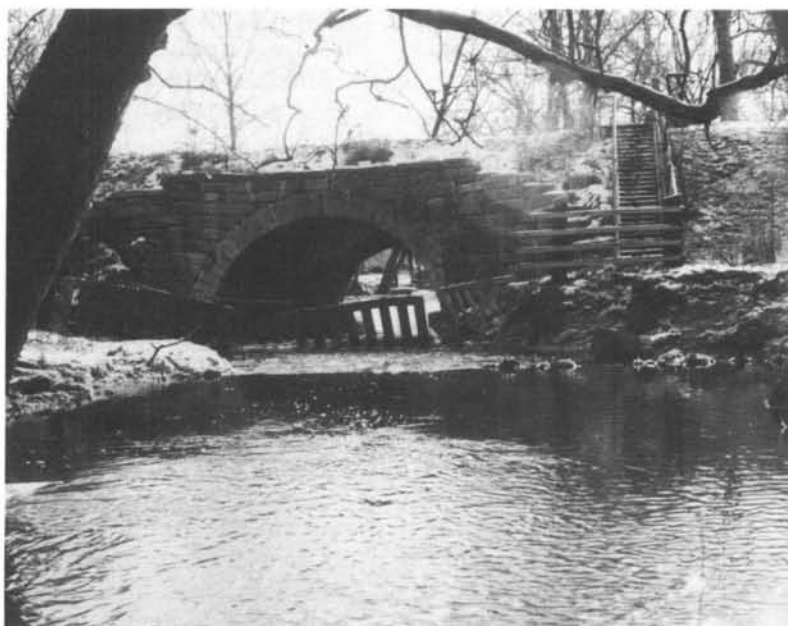
FIGURE 1—BURNETT'S CREEK ARCH, 1974: NORTH PORTAL OF TWENTY-FOOT ARCH CARRYING WABASH AND ERIE CANAL OVER BURNETT'S CREEK, CARROLL COUNTY; BUILT 1839-1840

one of the largest original arches has survived until the present day: culvert number 100, the stone arch that carried the canal over Burnett's Creek in Carroll County (Fig. 1).<sup>26</sup>

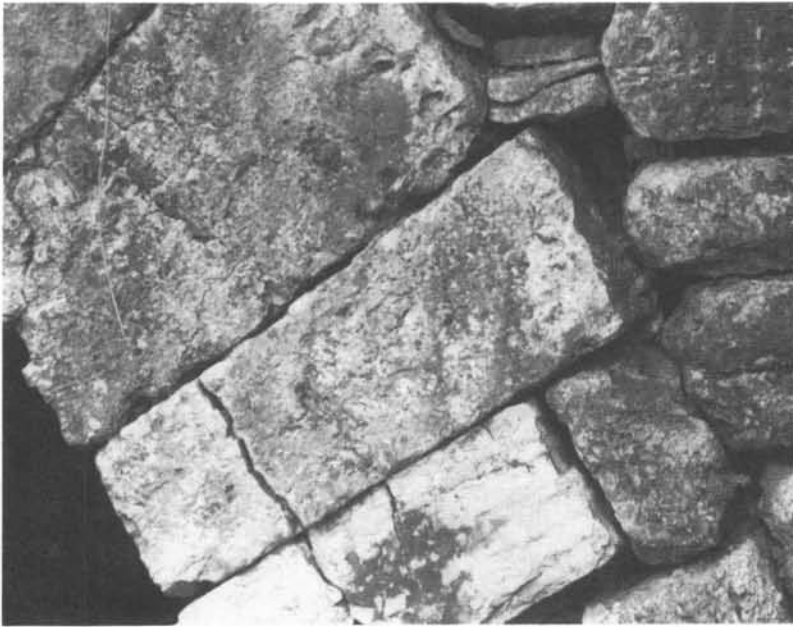
FIGURE 2—CRACKED RING STONES, BURNETT'S CREEK ARCH, 1974: COMPRESSION FRACTURES ARE VISIBLE IN RING STONES ON WEST PART OF THE NORTH PORTAL

today, as shown in the photo of the north face (Fig. 2).<sup>28</sup> County workers enveloped the south face in concrete to prevent further weakening from the same cause (Fig. 3).<sup>29</sup>

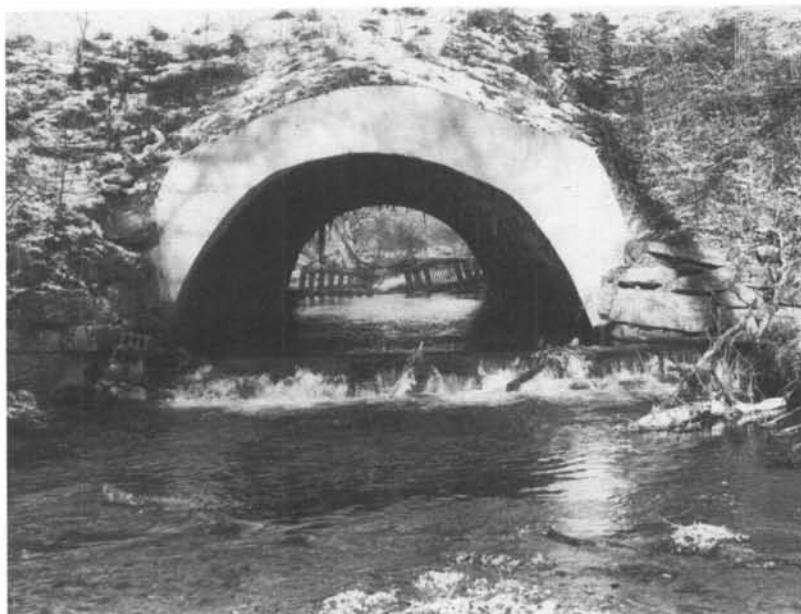
FIGURE 3—BURNETT'S CREEK ARCH, 1974: THE SOUTH PORTAL IS ENCASED IN CONCRETE. VISIBLE IN THE FOREGROUND IS THE SMALL DAM USED TO KEEP THE WATER OVER THE FOUNDATION TIMBERS UNDER THE ARCH.

<sup>10</sup> A similar small dam, which was used in conjunction with a stone arch culvert, appears incidentally in Fig. 3. It ensures that water will cover the horizontal wooden foundation that underlies the spring points and entire stream bed at this stone arch site.

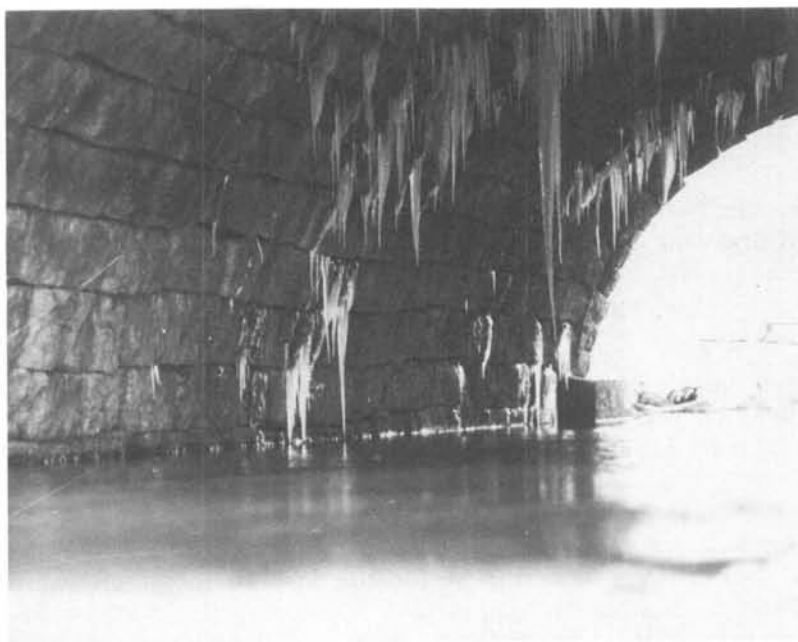
FIGURE 6—BURNETT'S CREEK ARCH, 1974: VIEW LOOKING NORTH FROM WATER LEVEL INSIDE THE ARCH, SHOWING ICICLES AND COURSES OF STONE

Canals sometimes leaked through the stone arches when the clay bed was new.<sup>30</sup> The winter photo (Fig. 6) showing
