Whitman Mission National Historic Site Accessibility Assessment

Summary Report Findings and Recommendations

May 2013

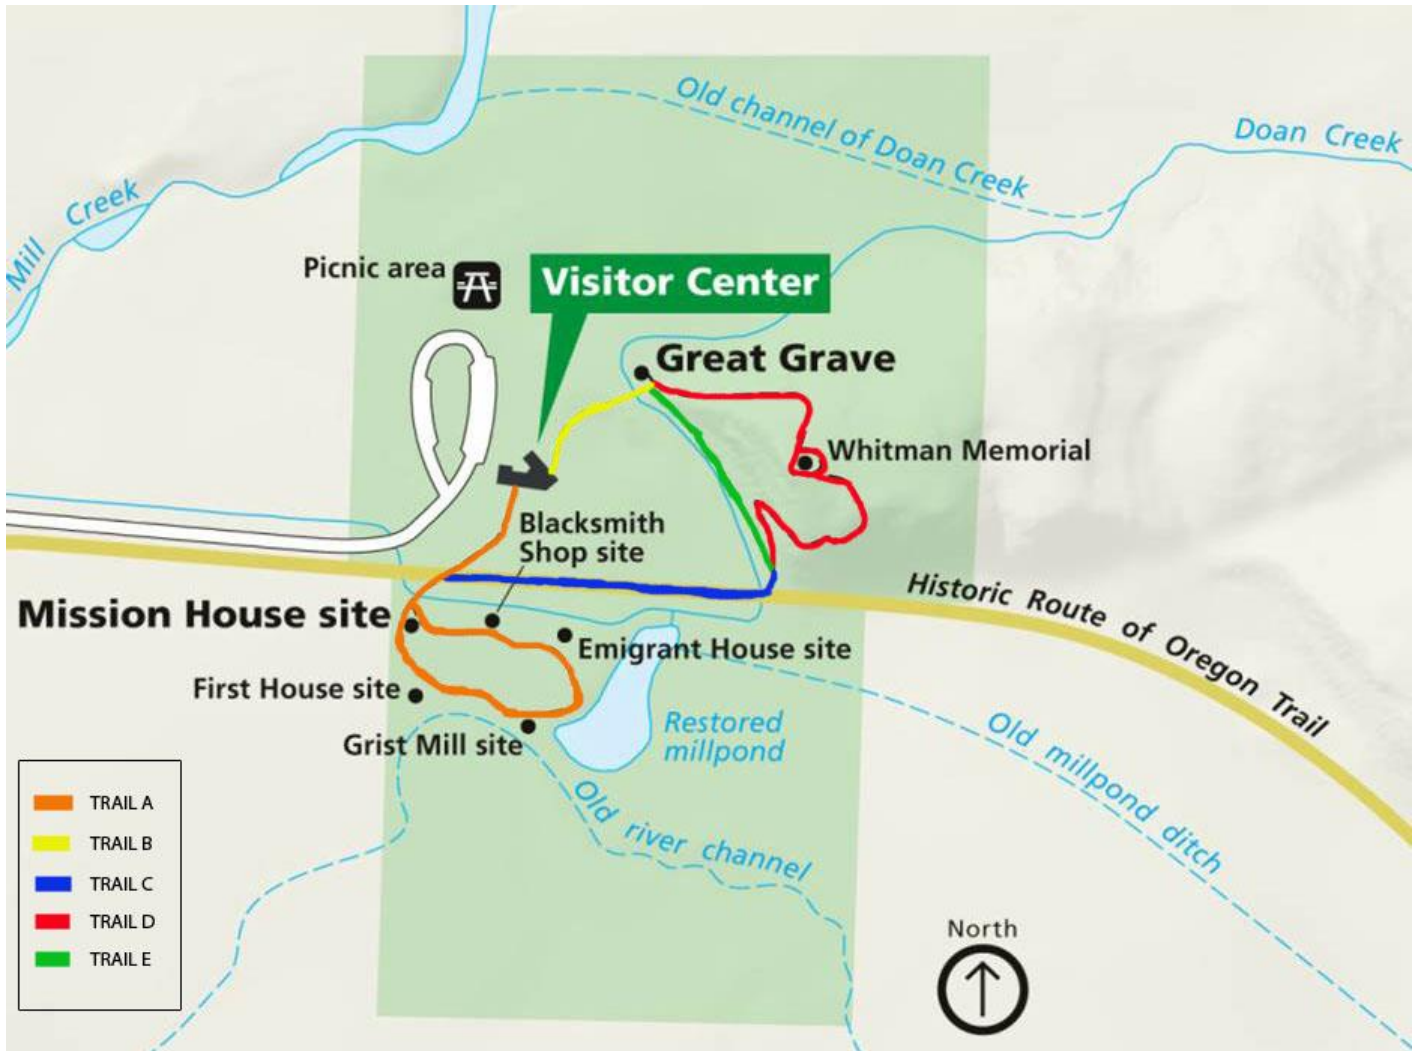
Appendix A

The appendix at the conclusion of this document visually identifies the trail segments evaluated by the assessment team from the National Center on Accessibility. It is the responsibility of the Park to conduct condition assessments of any new and/or altered trails, make accessibility findings available to the public, and integrate the information into the recommendations for trail accessibility improvements as identified below and within the associated FMSS work orders. Trail segment B and D are the only two trail segments within Whitman Mission NHS that contained deficiencies, the other three trail segments meet the recommendations for accessible trail segments.
